CORRIGENDA

Installation procedure leaflet contain misdescription. Refer to the following table and confirm the descriptions that are corrected.

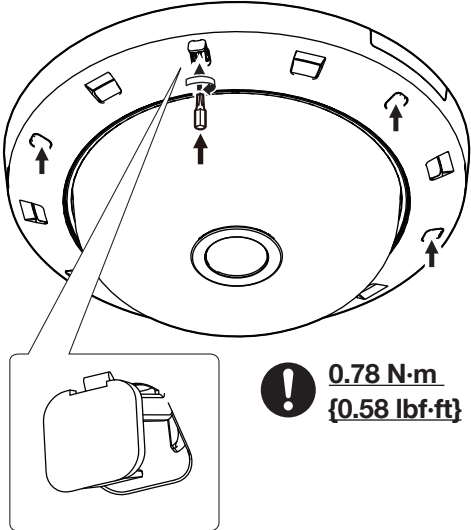
Incorrect	Correct
<p data-bbox="145 370 285 426">Step7</p>

<p data-bbox="560 751 767 813">! <u>0.78 N·m</u> <u>{0.58 lbf·ft}</u></p>	<p data-bbox="823 370 963 426">Step7</p>

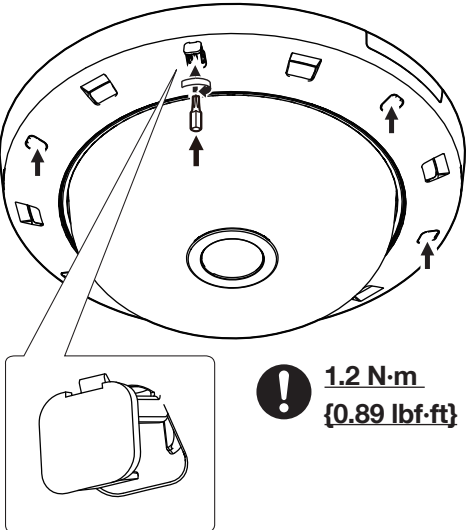
<p data-bbox="1241 751 1449 813">! <u>1.2 N·m</u> <u>{0.89 lbf·ft}</u></p>

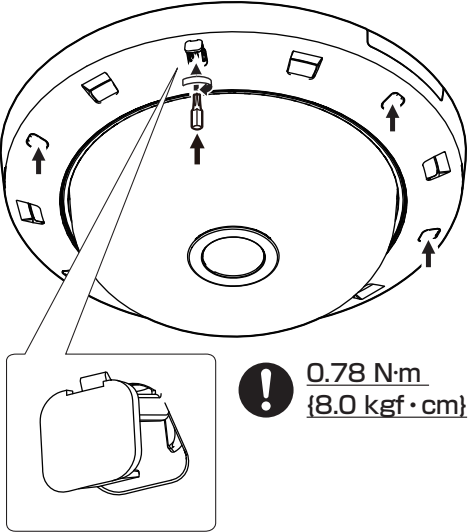
誤	正
<p data-bbox="145 337 288 393">Step7</p>

<p data-bbox="544 712 775 768">! <u>0.78 N·m</u> {8.0 kgf·cm}</p>	<p data-bbox="823 337 967 393">Step7</p>

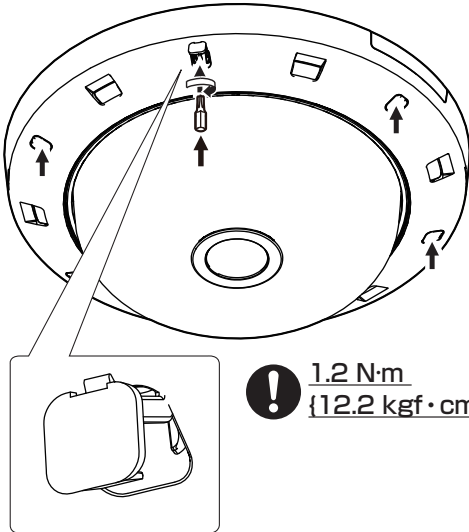
<p data-bbox="1222 712 1469 768">! <u>1.2 N·m</u> {12.2 kgf·cm}</p>
